Report on
Preliminary Geotechnical Investigation

Proposed Residential Subdivision
Goulburn Street, Marulan

Prepared for
Darraby Pty Ltd

Project 88505.06
July 2022

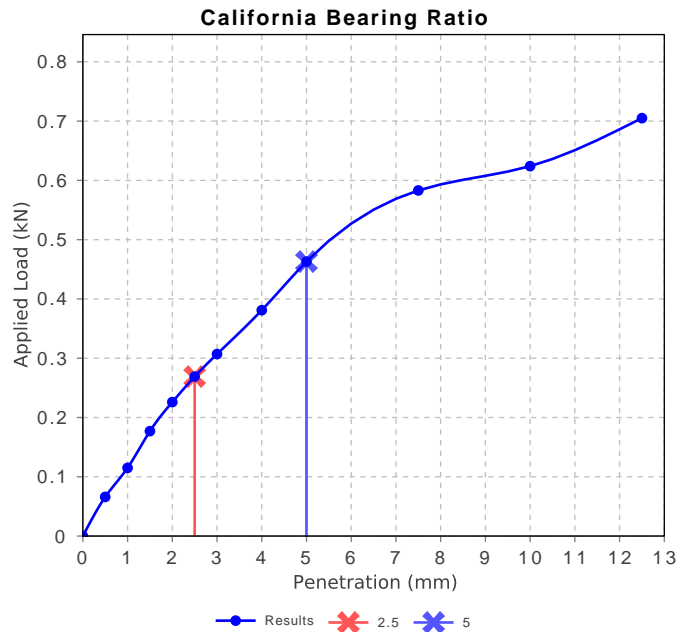
California Bearing Ratio (AS 1289 6.1.1 & 2.1.1)		Min	Max
CBR taken at	5 mm		
CBR %	2.5		
Method of Compactive Effort	Standard		
Method used to Determine MDD	AS 1289 5.1.1 & 2.1.1		
Method used to Determine Plasticity	Visual Assessment		
Maximum Dry Density (t/m ³)	1.50		
Optimum Moisture Content (%)	27.5		
Laboratory Density Ratio (%)	99.0		
Laboratory Moisture Ratio (%)	99.0		
Moisture Content at Placement (%)	27.3		
Moisture Content Top 30mm (%)	35.6		
Mass Surcharge (kg)	4.5		
Soaking Period (days)	4		
Curing Hours	120.0		
Oversize Material (mm)	19		
Oversize Material Included	Excluded		
Oversize Material (%)	0

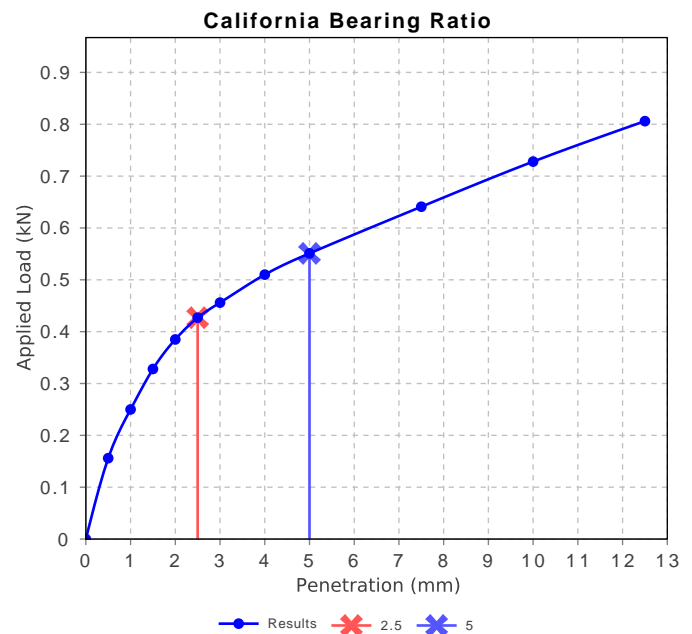
California Bearing Ratio (AS 1289 6.1.1 & 2.1.1)		Min	Max
CBR taken at	2.5 mm		
CBR %	3.0		
Method of Compactive Effort	Standard		
Method used to Determine MDD	AS 1289 5.1.1 & 2.1.1		
Method used to Determine Plasticity	Visual Assessment		
Maximum Dry Density (t/m ³)	1.50		
Optimum Moisture Content (%)	25.5		
Laboratory Density Ratio (%)	100.0		
Laboratory Moisture Ratio (%)	107.0		
Moisture Content at Placement (%)	27.5		
Moisture Content Top 30mm (%)	32.7		
Mass Surcharge (kg)	4.5		
Soaking Period (days)	4		
Curing Hours	100.0		
Oversize Material (mm)	19		
Oversize Material Included	Excluded		
Oversize Material (%)	0

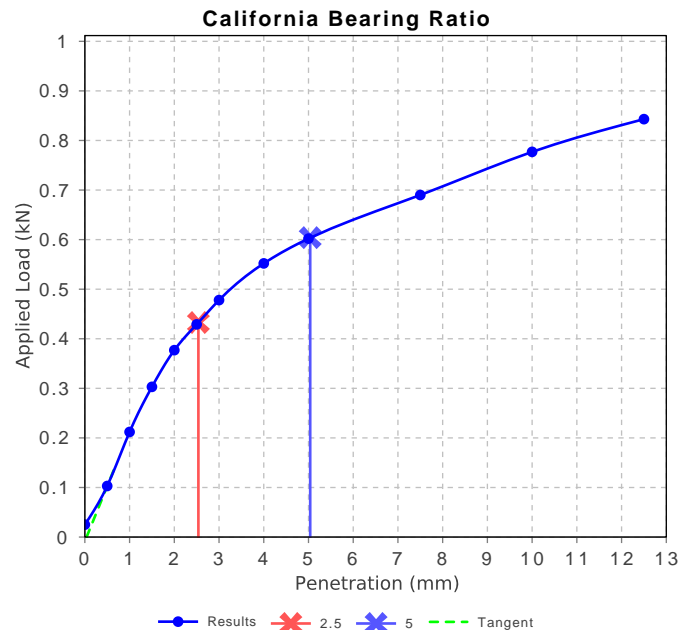
California Bearing Ratio (AS 1289 6.1.1 & 2.1.1)		Min	Max
CBR taken at	2.5 mm		
CBR %	3.5		
Method of Compactive Effort	Standard		
Method used to Determine MDD	AS 1289 5.1.1 & 2.1.1		
Method used to Determine Plasticity	Visual Assessment		
Maximum Dry Density (t/m ³)	1.59		
Optimum Moisture Content (%)	22.5		
Laboratory Density Ratio (%)	98.5		
Laboratory Moisture Ratio (%)	107.5		
Moisture Content at Placement (%)	24.0		
Moisture Content Top 30mm (%)	26.6		
Mass Surcharge (kg)	4.5		
Soaking Period (days)	4		
Curing Hours	120.0		
Oversize Material (mm)	19		
Oversize Material Included	Excluded		
Oversize Material (%)	0

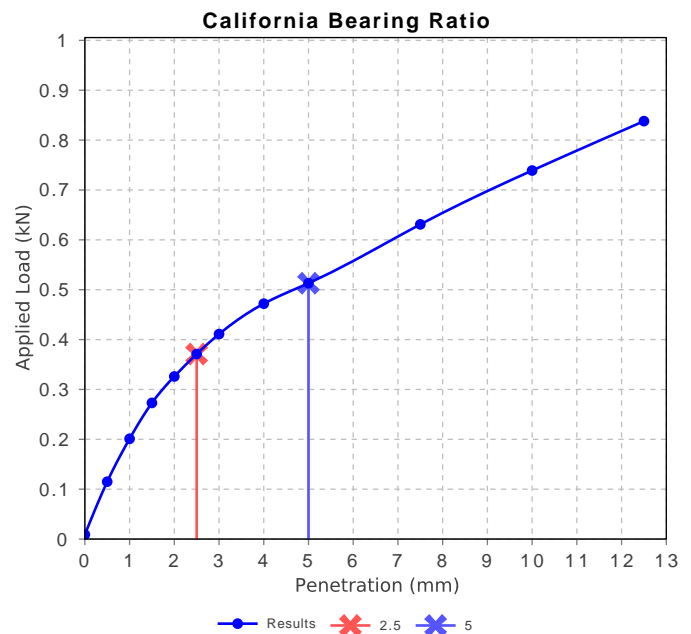
California Bearing Ratio (AS 1289 6.1.1 & 2.1.1)		Min	Max
CBR taken at	2.5 mm		
CBR %	3.0		
Method of Compactive Effort	Standard		
Method used to Determine MDD	AS 1289 5.1.1 & 2.1.1		
Method used to Determine Plasticity	Visual Assessment		
Maximum Dry Density (t/m ³)	1.54		
Optimum Moisture Content (%)	27.0		
Laboratory Density Ratio (%)	99.5		
Laboratory Moisture Ratio (%)	101.5		
Moisture Content at Placement (%)	27.3		
Moisture Content Top 30mm (%)	30.6		
Mass Surcharge (kg)	4.5		
Soaking Period (days)	4		
Curing Hours	112.9		
Oversize Material (mm)	19		
Oversize Material Included	Excluded		
Oversize Material (%)	0

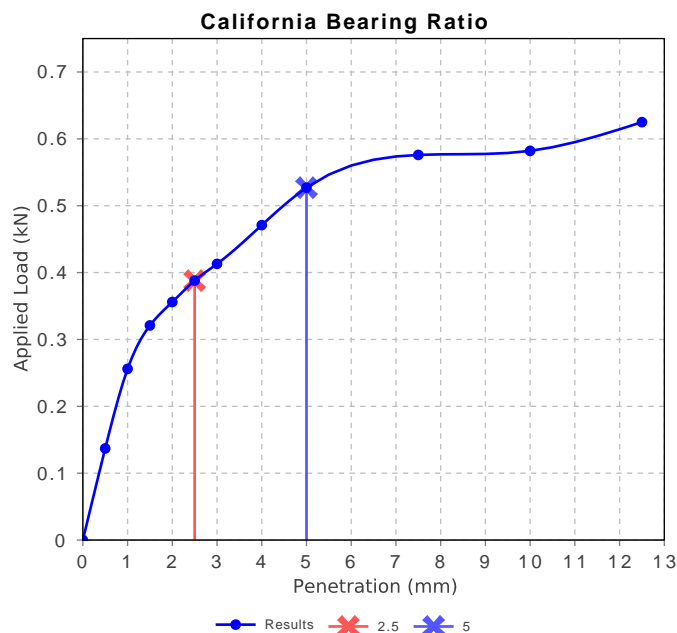
California Bearing Ratio (AS 1289 6.1.1 & 2.1.1)		Min	Max
CBR taken at	2.5 mm		
CBR %	3.0		
Method of Compactive Effort	Standard		
Method used to Determine MDD	AS 1289 5.1.1 & 2.1.1		
Method used to Determine Plasticity	Visual Assessment		
Maximum Dry Density (t/m ³)	1.53		
Optimum Moisture Content (%)	27.0		
Laboratory Density Ratio (%)	99.5		
Laboratory Moisture Ratio (%)	100.5		
Moisture Content at Placement (%)	27.2		
Moisture Content Top 30mm (%)	31.7		
Mass Surcharge (kg)	4.5		
Soaking Period (days)	4		
Curing Hours	120.0		
Oversize Material (mm)	19		
Oversize Material Included	Excluded		
Oversize Material (%)	0.0

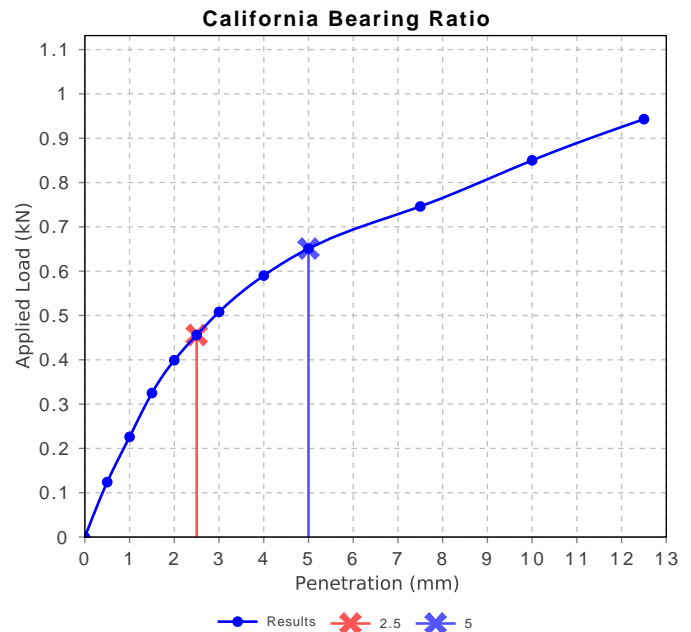
California Bearing Ratio (AS 1289 6.1.1 & 2.1.1)		Min	Max
CBR taken at	2.5 mm		
CBR %	3.5		
Method of Compactive Effort	Standard		
Method used to Determine MDD	AS 1289 5.1.1 & 2.1.1		
Method used to Determine Plasticity	Visual Assessment		
Maximum Dry Density (t/m ³)	1.64		
Optimum Moisture Content (%)	20.0		
Laboratory Density Ratio (%)	99.5		
Laboratory Moisture Ratio (%)	111.5		
Moisture Content at Placement (%)	22.2		
Moisture Content Top 30mm (%)	27.4		
Mass Surcharge (kg)	4.5		
Soaking Period (days)	4		
Curing Hours	168.0		
Oversize Material (mm)	19		
Oversize Material Included	Excluded		
Oversize Material (%)	0

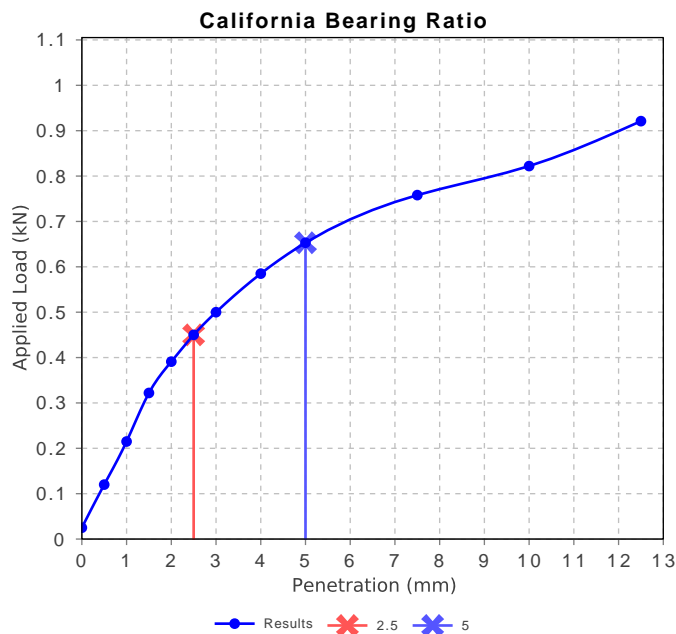
California Bearing Ratio (AS 1289 6.1.1 & 2.1.1)		Min	Max
CBR taken at	2.5 mm		
CBR %	3.5		
Method of Compactive Effort	Standard		
Method used to Determine MDD	AS 1289 5.1.1 & 2.1.1		
Method used to Determine Plasticity	Visual Assessment		
Maximum Dry Density (t/m ³)	1.61		
Optimum Moisture Content (%)	22.5		
Laboratory Density Ratio (%)	100.0		
Laboratory Moisture Ratio (%)	100.0		
Moisture Content at Placement (%)	22.7		
Moisture Content Top 30mm (%)	28.6		
Mass Surcharge (kg)	4.5		
Soaking Period (days)	4		
Curing Hours	99.0		
Oversize Material (mm)	19		
Oversize Material Included	Excluded		
Oversize Material (%)	0

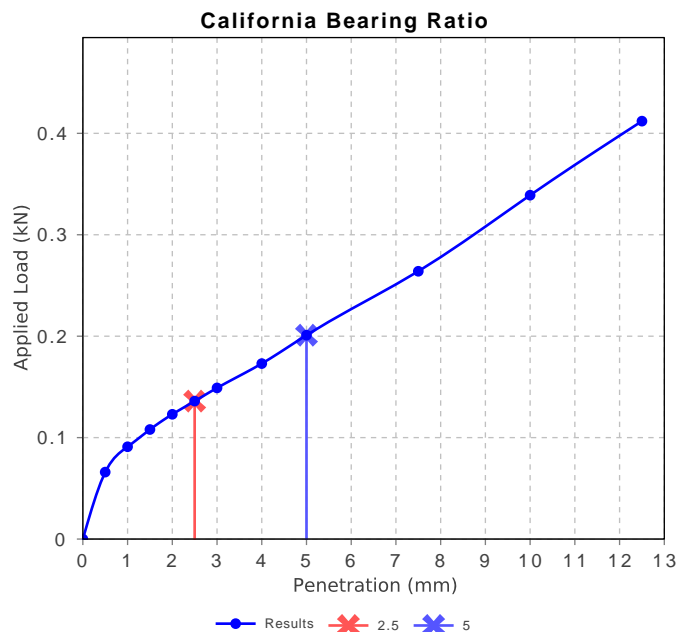
California Bearing Ratio (AS 1289 6.1.1 & 2.1.1)		Min	Max
CBR taken at	2.5 mm		
CBR %	1.0		
Method of Compactive Effort	Standard		
Method used to Determine MDD	AS 1289 5.1.1 & 2.1.1		
Method used to Determine Plasticity	Visual Assessment		
Maximum Dry Density (t/m ³)	1.58		
Optimum Moisture Content (%)	22.0		
Laboratory Density Ratio (%)	100.5		
Laboratory Moisture Ratio (%)	100.5		
Moisture Content at Placement (%)	21.9		
Moisture Content Top 30mm (%)	32.4		
Mass Surcharge (kg)	4.5		
Soaking Period (days)	4		
Curing Hours	99.1		
Oversize Material (mm)	19		
Oversize Material Included	Excluded		
Oversize Material (%)	0
