**PROPOSED RURAL SUBDIVISION  
407 CROOKWELL ROAD, KINGSDALE, NSW  
EFFLUENT DISPOSAL – SITE AND SOIL EVALUATION**

At the request of Southern Region Land Engineering, ACT Geotechnical Engineers Pty. Ltd carried out an effluent disposal assessment to AS1547 "On-Site domestic wastewater management", for the proposed rural subdivision at 407 Crookwell Road, in Kingsdale, NSW.

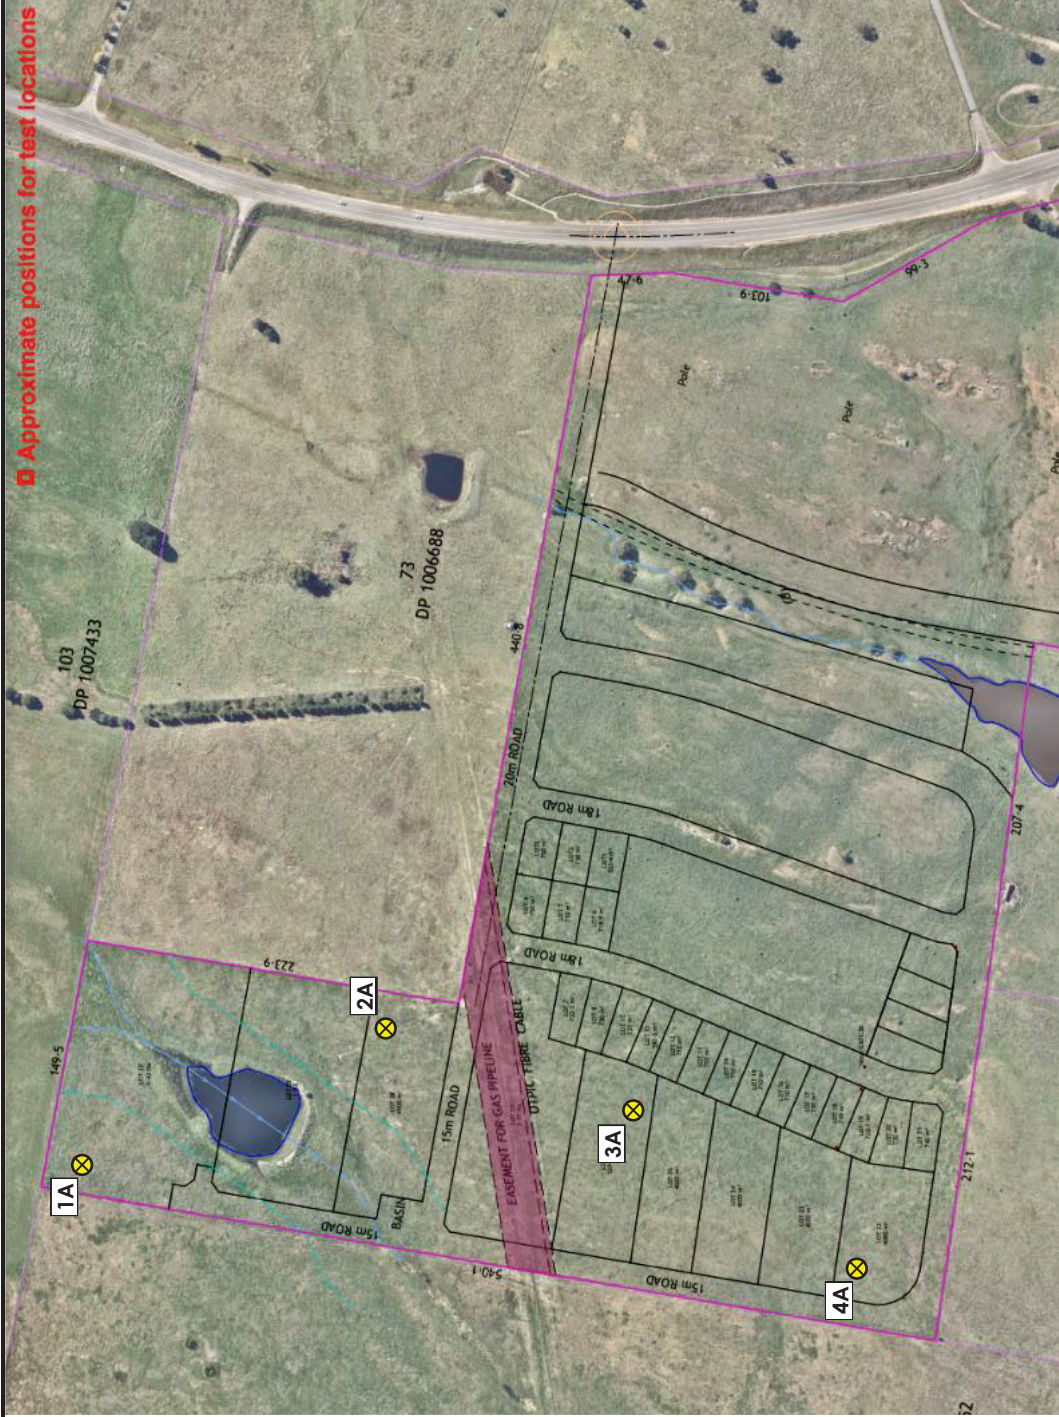
To establish the subsurface conditions, four (4) test holes were drilled at client-provided locations around the proposed subdivision. Figure 1 shows the site locality, while Figures 2 and 3 are aerial photographs showing the location of the investigation boreholes. The subsurface profiles were logged in terms of the Unified Soil Classification System (USCS). The borehole logs can be found in Appendix B.

SOUTHERN REGION LAND ENGINEERING  
 RURAL SUBDIVISION – 407 CROOKWELL ROAD, KINGSDALE, NSW  
 AERIAL PHOTOGRAPH AND BOREHOLE LOCATIONS

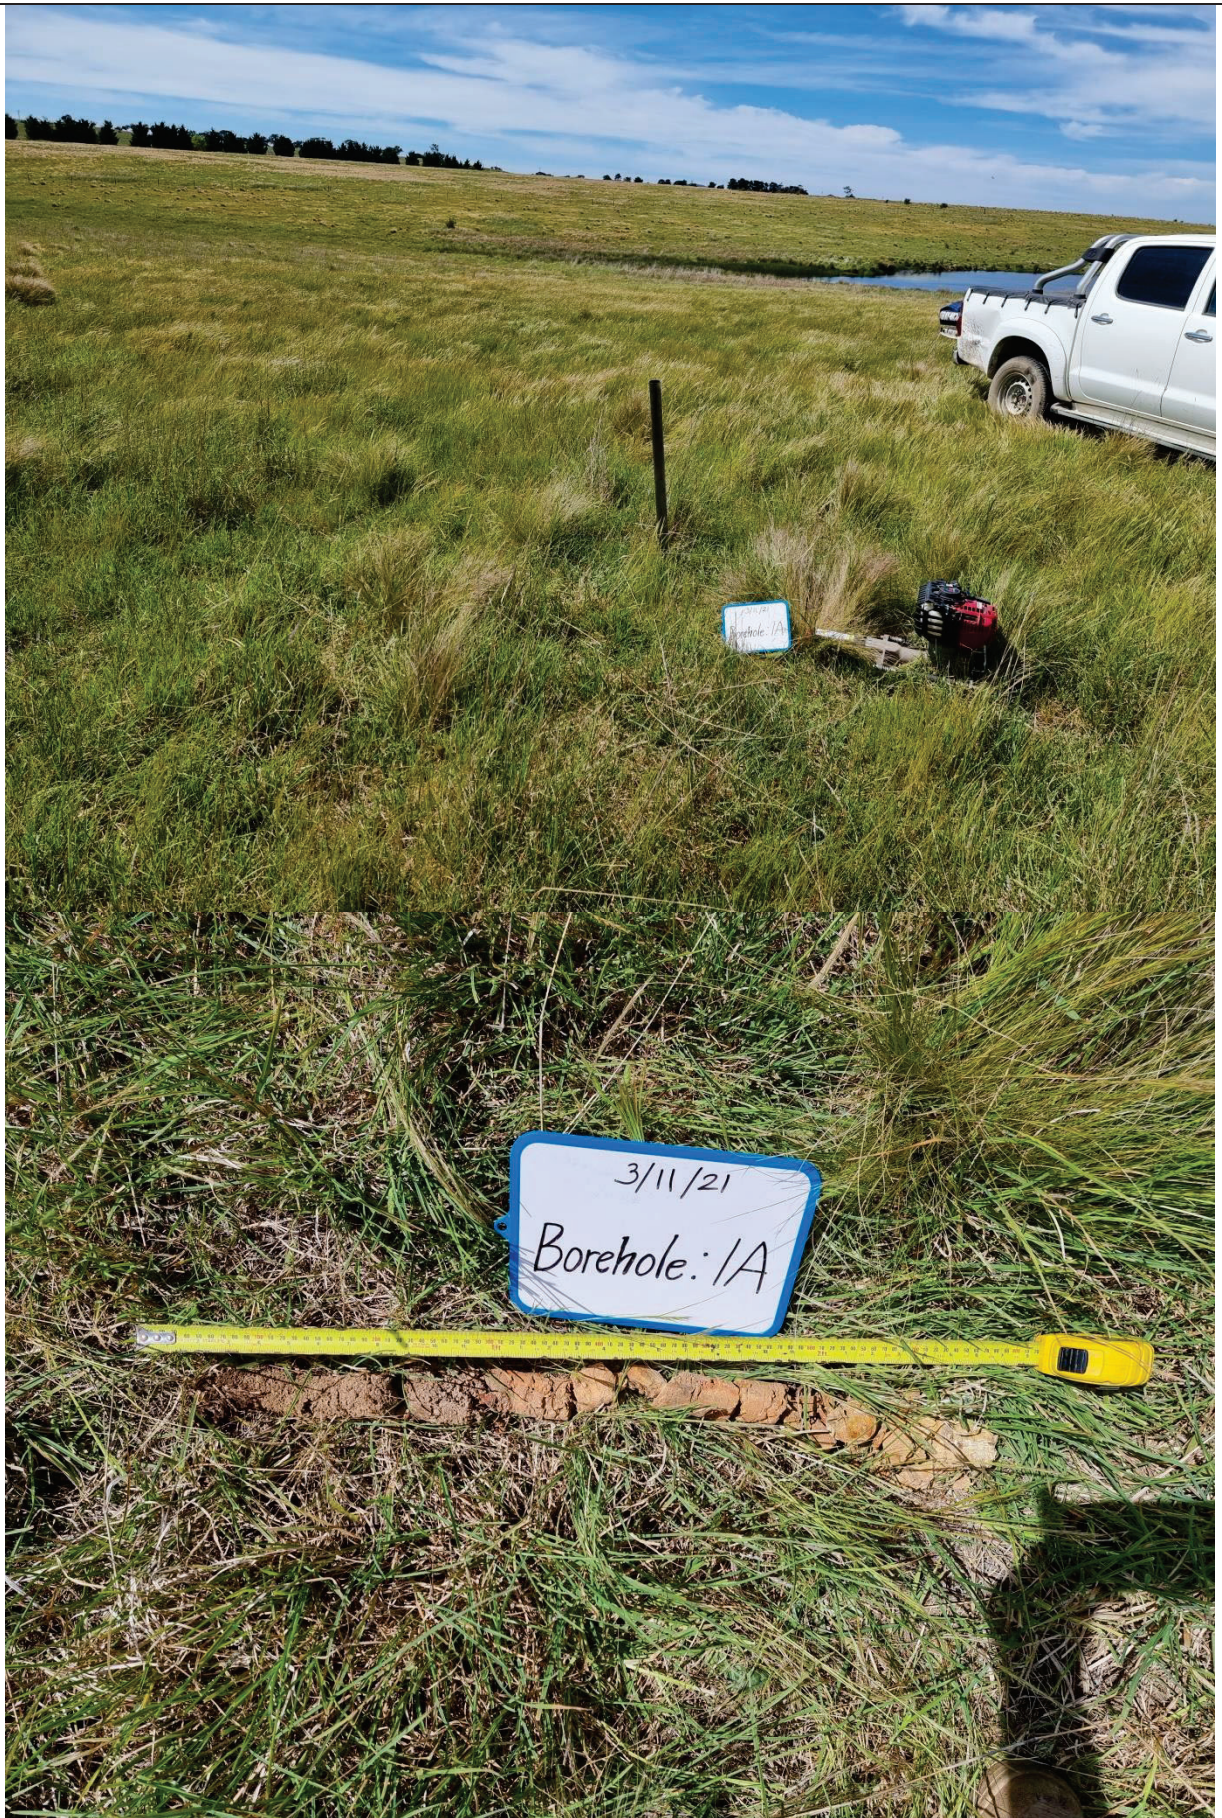
**SOUTHERN REGION LAND ENGINEERING  
RURAL SUBDIVISION – 407 CROOKWELL ROAD, KINGSDALE, NSW  
LOCATION AND SOIL CORE PHOTOS (1A)**

Samples	Casing	Depth Metres	Graphic Log	U.S.C.S.	Material Description, Structure <small>Soil Type: Plasticity or Particle Characteristics, Colour, Secondary and Minor Components, Moisture, Structure</small>	Consistency or Relative Density	Field Test Results	Geological Profile
		0.1		SM	Silty SAND; fine to medium grained sand, low plasticity silt, brown, dry, with grass rootlets.	LOOSE		TOPSOIL
		0.3		SM	Silty SAND: fine to medium grained sand, low plasticity silt, grey-brown, dry.	LOOSE		SLOPEWASH
		0.6		CL-CH	Sandy Gravelly CLAY; medium plasticity clay, fine to coarse sand, fine to coarse gravel, orange-brown, dry.	VERY STIFF		RESIDUAL SOIL
		0.8			Extremely to Highly Weathered (EW-HW) SILTSTONE; fine to medium grained, light brown, dry.	EXTREMELY WEAK TO VERY WEAK		BEDROCK
		1.0			BOREHOLE TERMINATED AT 0.8m refusal in bedrock			
		1.5

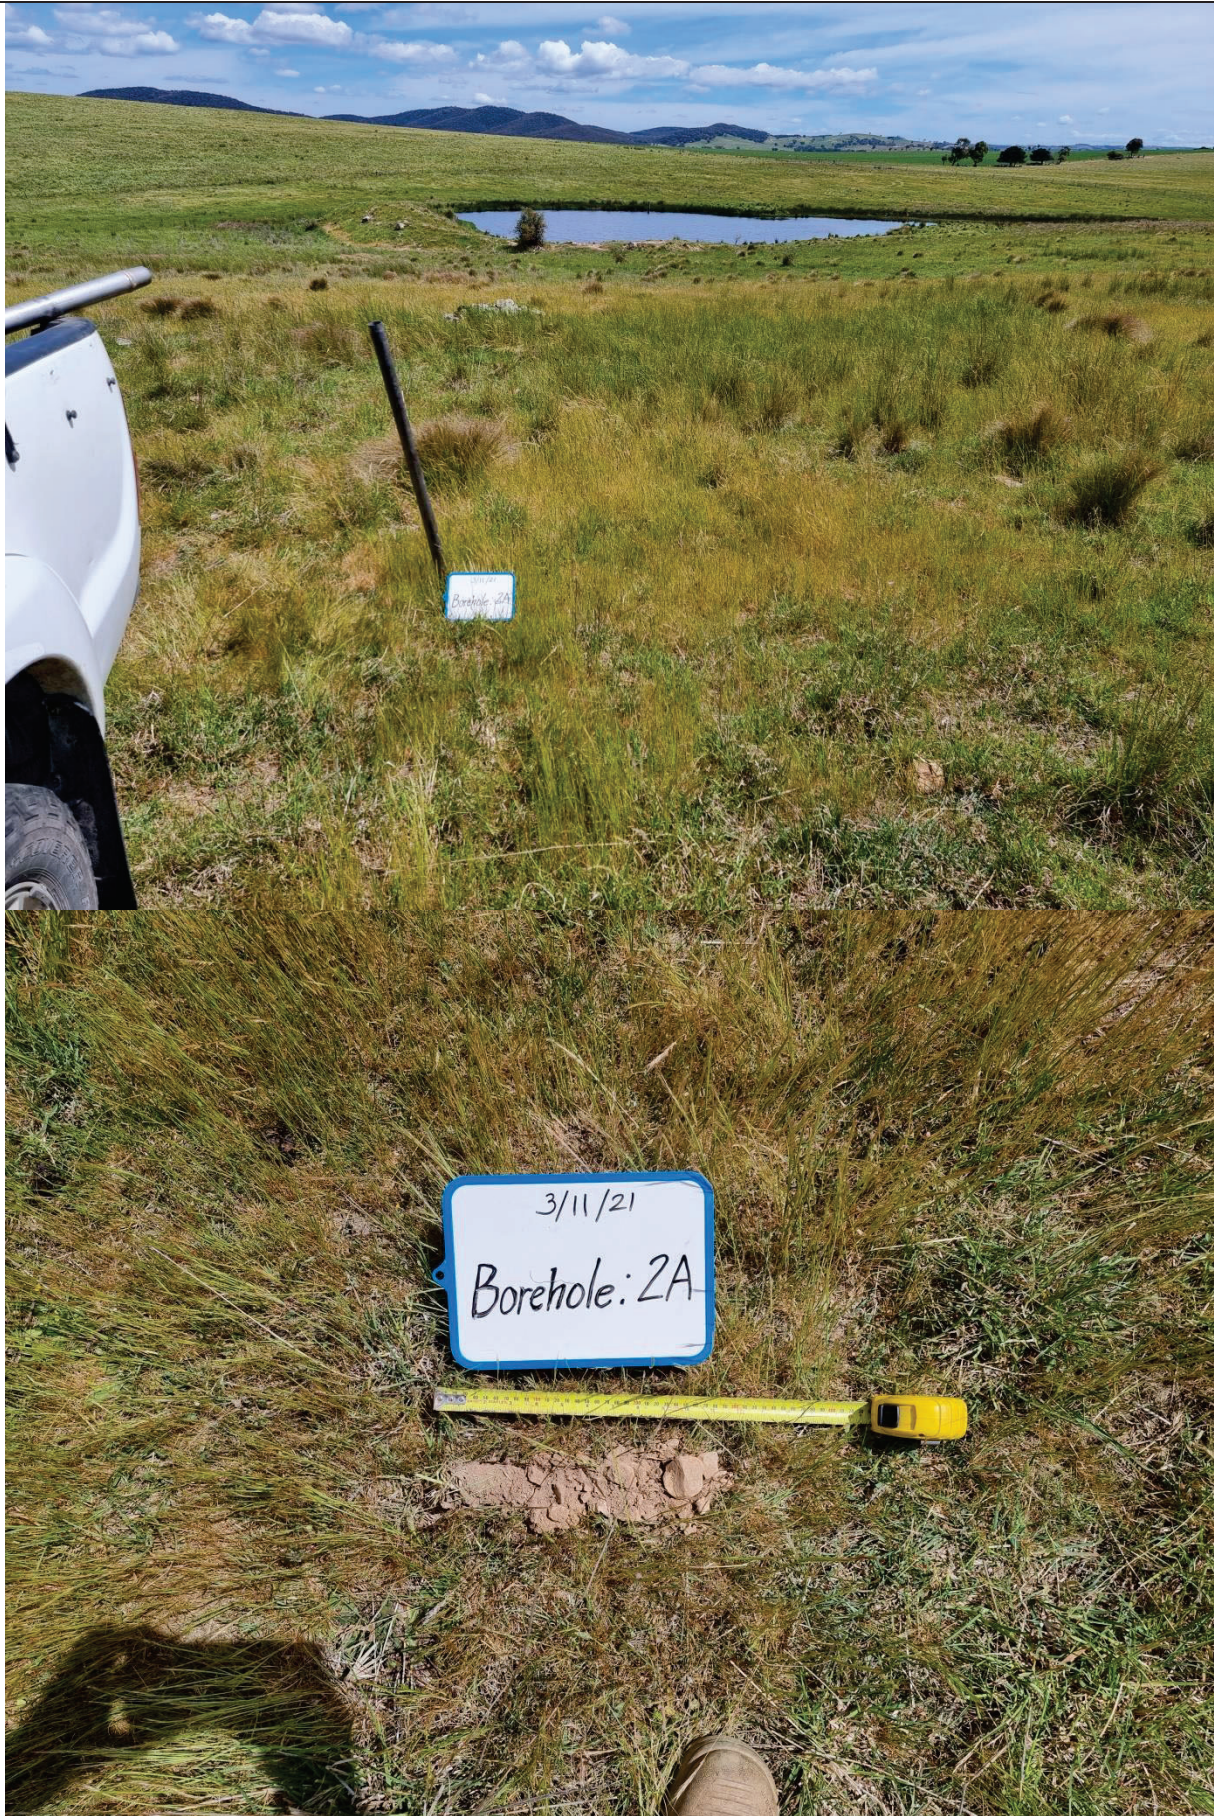
**SOUTHERN REGION LAND ENGINEERING  
RURAL SUBDIVISION – 407 CROOKWELL ROAD, KINGSDALE, NSW  
LOCATION AND SOIL CORE PHOTOS (2A)**

Samples	Casing	Depth Metres	Graphic Log	U.S.C.S.	Material Description, Structure <small>Soil Type: Plasticity or Particle Characteristics, Colour, Secondary and Minor Components, Moisture, Structure</small>	Consistency or Relative Density	Field Test Results	Geological Profile
		0.2		SM	Silty SAND; fine to medium grained sand, low plasticity silt, some gravel to 10mm, dry.	LOOSE		TOPSOIL
		0.3			Extremely to Highly Weathered (EW-HW) SILTSTONE; fine to medium grained, light brown, dry.	EXTREMELY WEAK TO VERY WEAK		BEDROCK
		1.0			BOREHOLE TERMINATED AT 0.3m refusal in bedrock			
		1.5

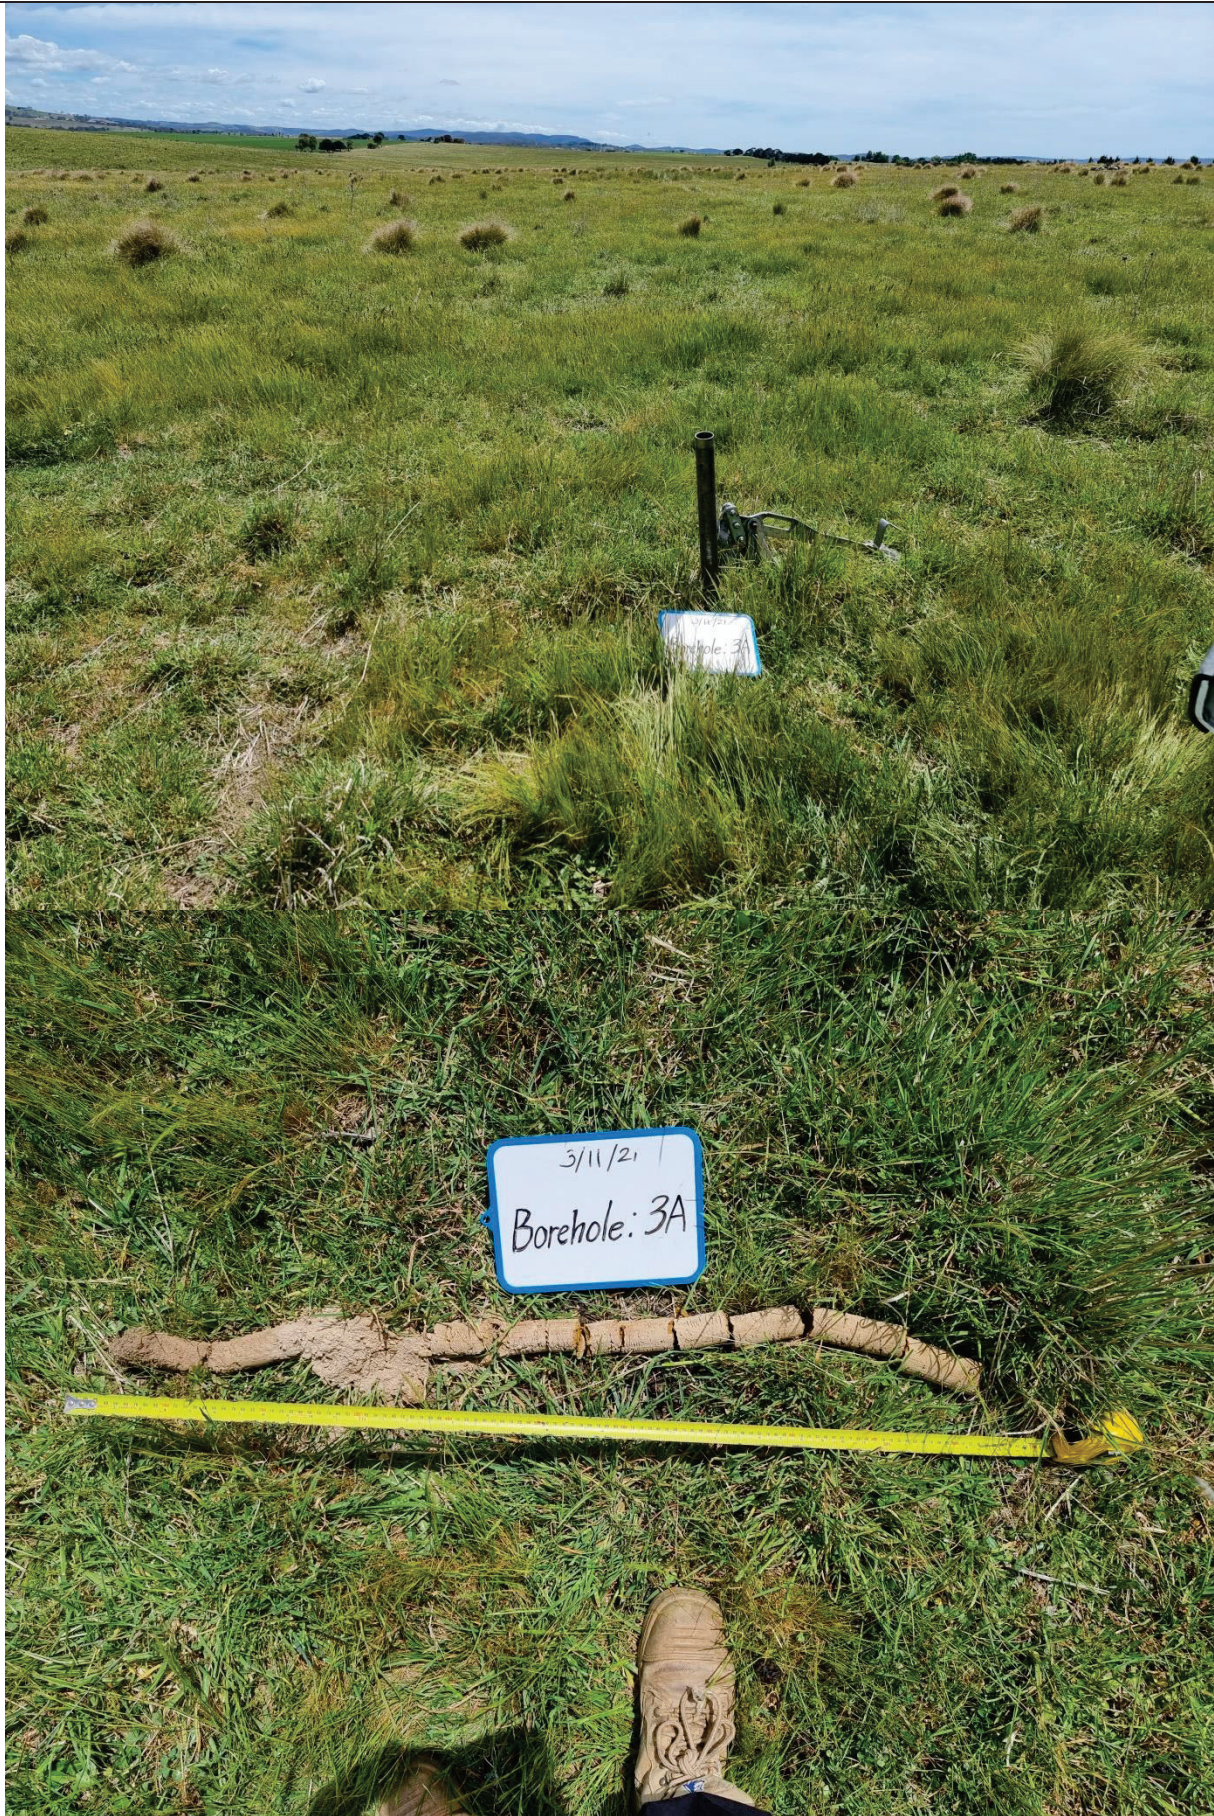
**SOUTHERN REGION LAND ENGINEERING  
RURAL SUBDIVISION – 407 CROOKWELL ROAD, KINGSDALE, NSW  
LOCATION AND SOIL CORE PHOTOS (3A)**

Samples	Casing	Depth Metres	Graphic Log	U.S.C.S.	Material Description, Structure <small>Soil Type: Plasticity or Particle Characteristics, Colour, Secondary and Minor Components, Moisture, Structure</small>	Consistency or Relative Density	Field Test Results	Geological Profile
		0.1		SM	Silty SAND; fine to medium grained sand, low plasticity silt, brown, dry, with grass rootlets.	LOOSE		TOPSOIL
				SM	Silty SAND: fine to medium grained sand, low plasticity silt, grey-brown, dry.	LOOSE		SLOPEWASH
		0.4		CL-CH	Sandy CLAY; medium plasticity clay, fine to coarse sand, orange-brown, dry.	STIFF TO VERY STIFF		RESIDUAL SOIL
		1.0						
		1.5						
					BOREHOLE TERMINATED AT 1m very slow progress

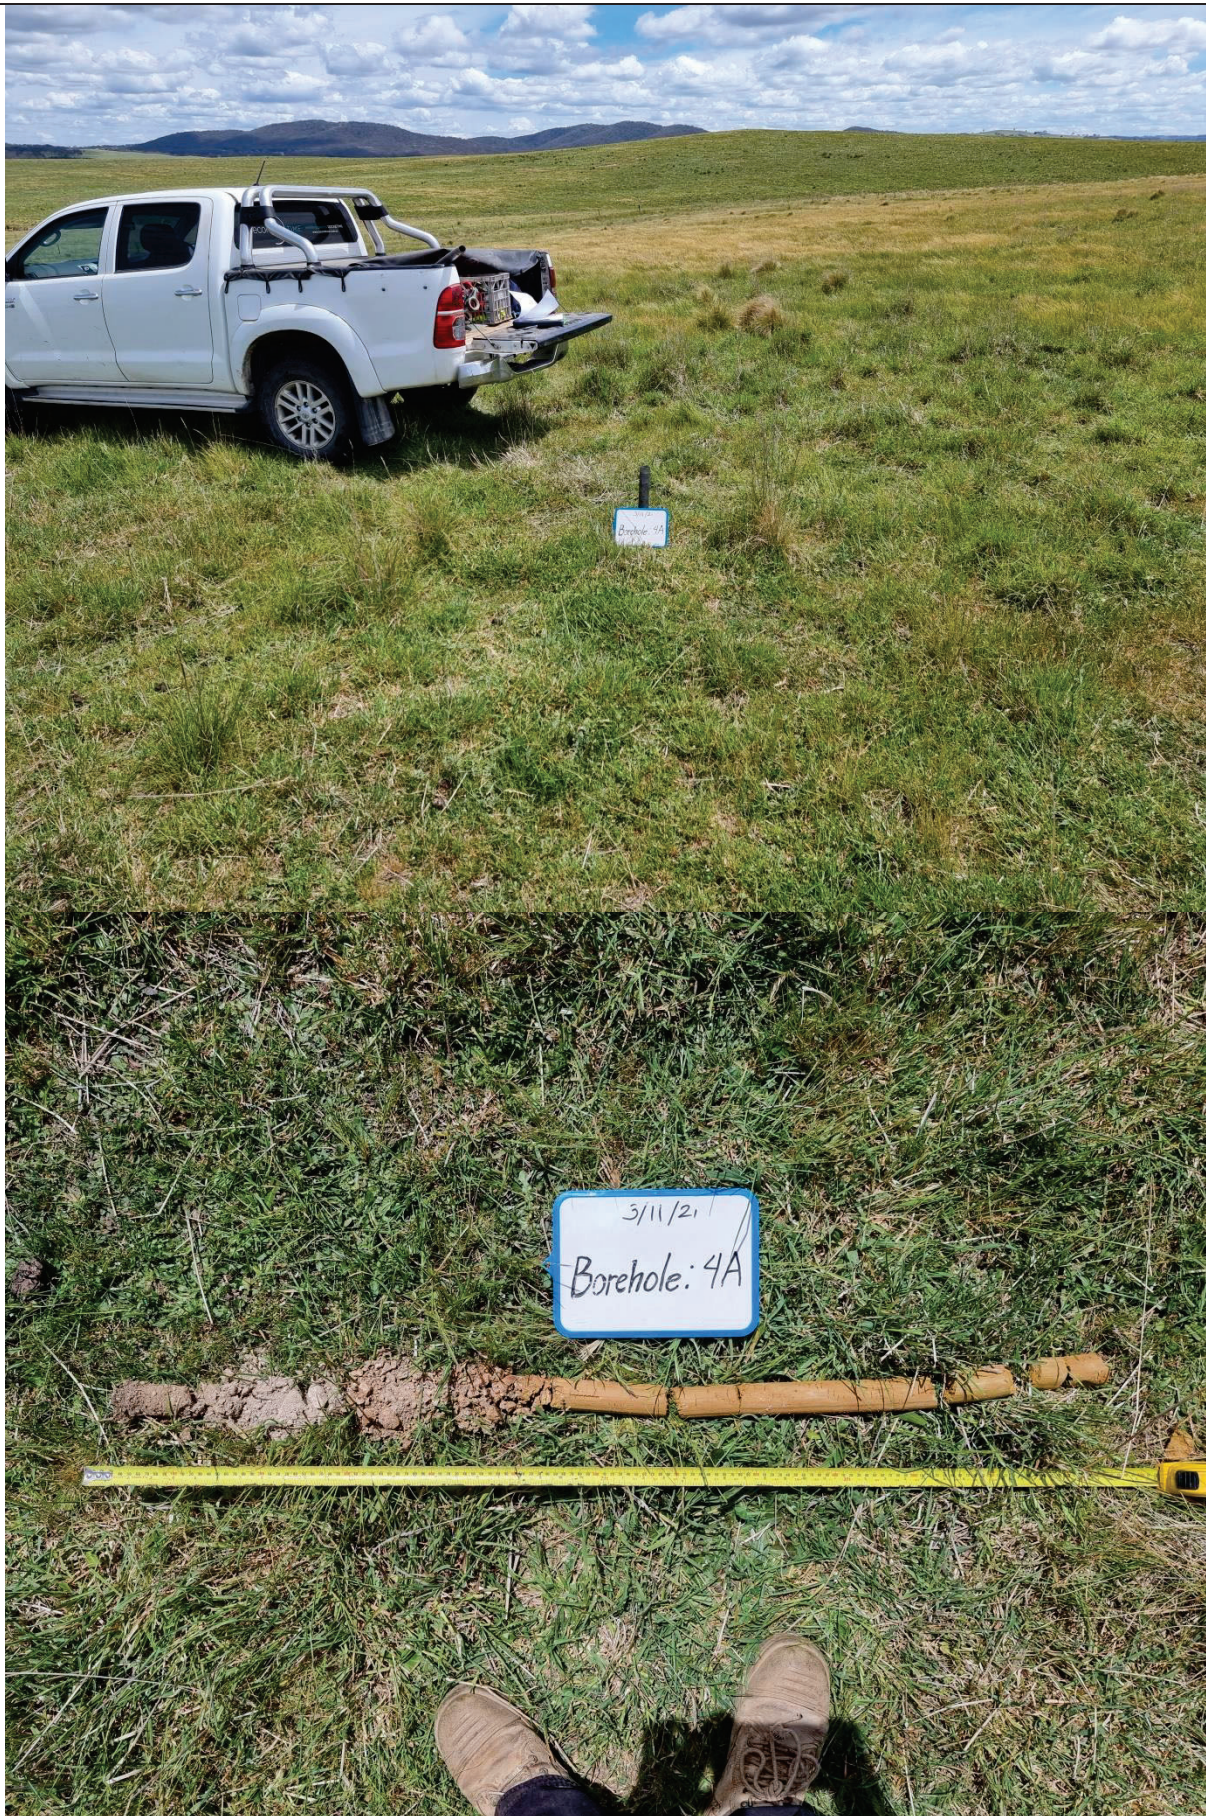
**SOUTHERN REGION LAND ENGINEERING  
RURAL SUBDIVISION – 407 CROOKWELL ROAD, KINGSDALE, NSW  
LOCATION AND SOIL CORE PHOTOS (4A)**

Samples	Casing	Depth Metres	Graphic Log	U.S.C.S.	Material Description, Structure <small>Soil Type: Plasticity or Particle Characteristics, Colour, Secondary and Minor Components, Moisture, Structure</small>	Consistency or Relative Density	Field Test Results	Geological Profile
		0.1		SM	Silty SAND; fine to medium grained sand, low plasticity silt, brown, dry, with grass rootlets.	LOOSE		TOPSOIL
		0.3		SM	Silty SAND: fine to medium grained sand, low plasticity silt, grey-brown, dry.	LOOSE		SLOPEWASH
		0.5		SC	Clayey Gravelly SAND; fine to coarse sand, fine to medium grained sedimentary gravel, low plasticity clay, grey/brown, dry.	MEDIUM DENSE		COLLUVIUM
		1.0		CH	Sandy CLAY; medium to high plasticity clay, fine to coarse sand, orange-grey, dry.	VERY STIFF		RESIDUAL SOIL
		1.2			BOREHOLE TERMINATED AT 1.2m			
		1.5
